Outbuildings and other Domestic and Agricultural Resources

Domestic Resources

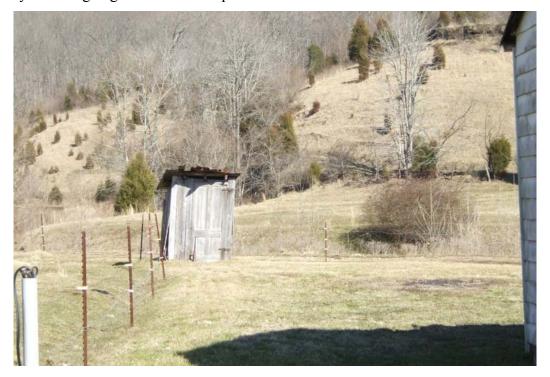
Figure 183: MN 604, Privy at the corner of the backyard, early-mid twentieth century, Bradfordsville vicinity.

Privies, or outdoor toilets, are common features of Kentucky's rural landscape. 95 examples were documented in the RHDI survey. They are often located within a convenient distance from the house. A common spot is near the edge of the domestic yard area, well away from the well or cistern, but still within walking distance, as at MN 604 (Figure 183). Their location was not necessarily fixed as they were sometimes moved to different locations over new pits. Several examples were documented with placement near other outbuildings, such as chicken houses, storage buildings, or shops (Figure 184). The typical privy is a small frame building, square or somewhat rectangular in plan, with a shed roof and a single door, as at WS 476, (Figure 185), WS 763 (Figure 186), and MN 664 (Figure 187). Somewhat more elaborate examples were found which featured gable roofs (MN 681, Figure 188), or gambrel roofs and windows (WS 355, Figure 189). Privies were also found at many churches (WS 763, Figure 186) and schools.

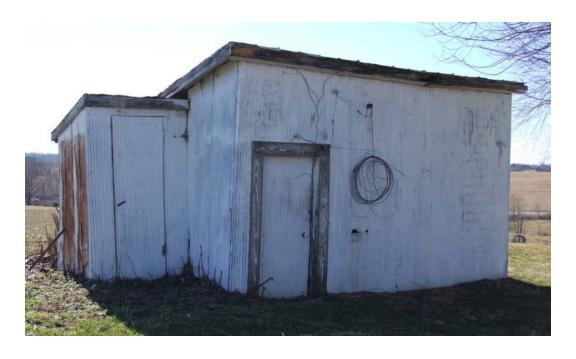
Figure 184: WS 590, Privy (left) attached to Chicken House (right), frame, early-mid twentieth century, Mackville vicinity.

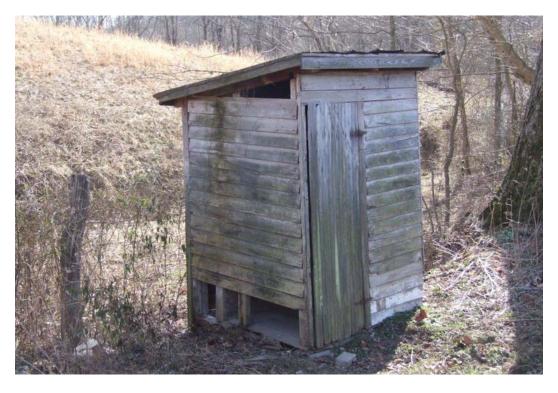
Figure 185: WS 476, Privy, twentieth century, Mackville vicinity.

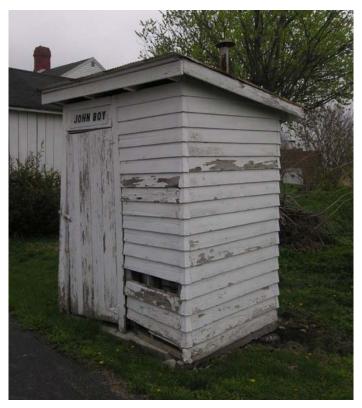
Figure 186: WS 763, Mackville Baptist Church Privy, frame, early – mid twentieth century

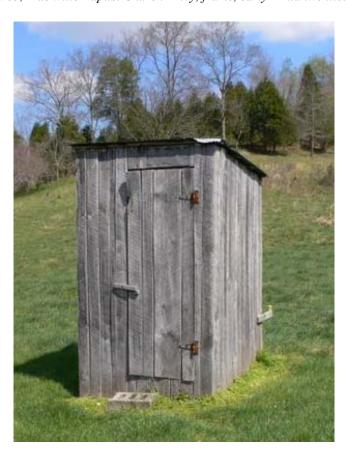
Figure 187: MN 664, Privy, mid twentieth century, Gravel Switch vicinity.

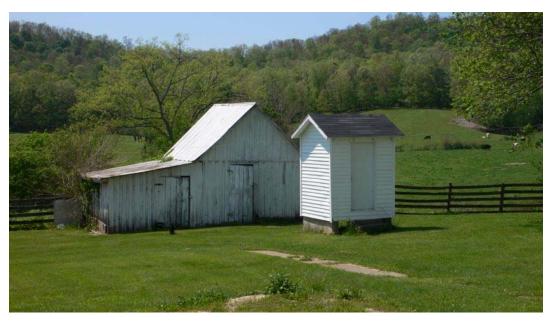
Figure 188, MN 681, Sweazy-Kirkland farm, Privy (front) and Gable-front Outbuilding, early twentieth century, Gravel Switch vicinity.

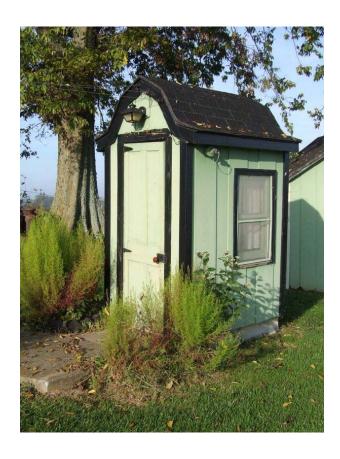
Figure 189: WS 355, Privy, mid - late twentieth century, Mooresville vicinity

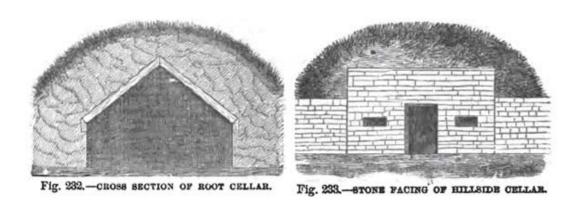
Figure 190: Section and elevation of a root cellar, from Byron D. Halsted, <u>Barn Plans and Outbuildings (New York: Orange Judd Co, 1898)</u>, 224-25.

The cellar may be dug into the side of a hill, down into the ground, or partially dug in and covered with a mound (Figure 190). It is often located behind the house, near the kitchen door, as at WS 476 (Figure 191, see also the site plan in Figure 3), but is sometimes found further away, particularly if a convenient hill is located near the domestic yard, as at WS 633 (Figure 193). An urban example is found at WS 171 (Figure 192),

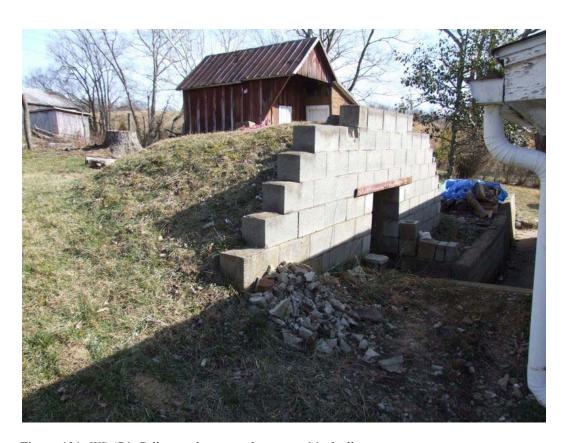
Figure 191: WS 476, Cellar, early twentieth century, Mackville vicinity.

Cellars are principally constructed of stone or brick masonry until the twentieth century, when materials such as concrete block (WS 476, Figure 191, MN 205, Figure 198) or poured concrete become more common.

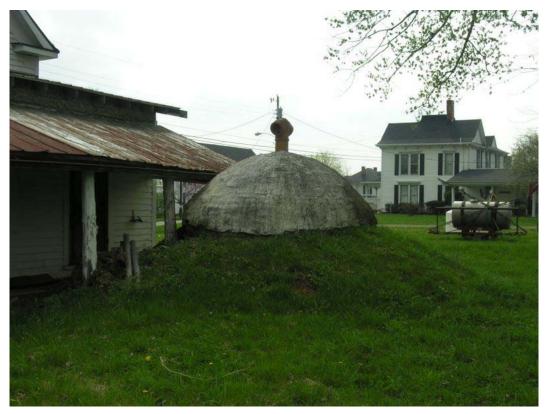
Figure 192: WS 171, Brick- domed Root Cellar, behind the John Harmon house, late nineteenth century, Mackville.

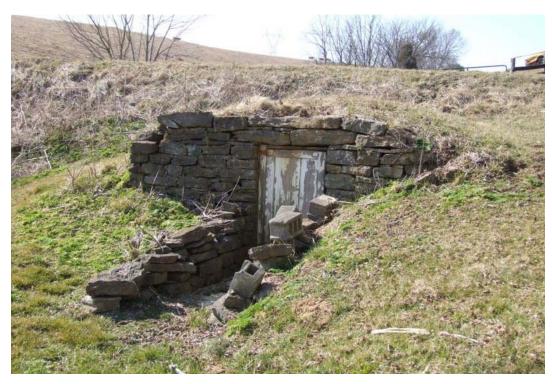
Figure 193: WS 633, Dry laid Stone Bank Cellar, late nineteenth century, Deep Creek vicinity.

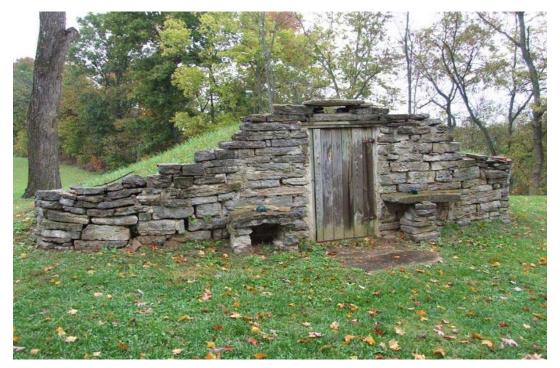
Figure 194: WS 365, Dry-laid Stone Cellar, late nineteenth century, Maud Vicinity.

Most cellars have a simple opening directly into the cellar space, often a doorway into a masonry retaining wall, such as the examples mentioned above, or WS 365 (Figure 194), or MN 273 (Figure 195). The interiors are lined with masonry, and some elaborate examples have domed ceilings, as at MN 273 (Figure 196). In some cellars, the entryway is covered by a small building which itself may be used for dry storage. The entry building may be frame, as at MN 480 (Figure 197), or masonry, as at MN 205 (Figure 198). Another type of storage building, sometimes called a *warmhouse* is unusual in this region, but found more frequently found in Eastern Kentucky. An example can be seen at WS 812 (Figure 200). The warmhouse is a two story building consisting of a cellar underneath with a small frame or log building above, creating a two story storage unit, with cooler, moist storage at the cellar level and warmer, dry storage above for tools, onions, seeds, cured meats, etc.

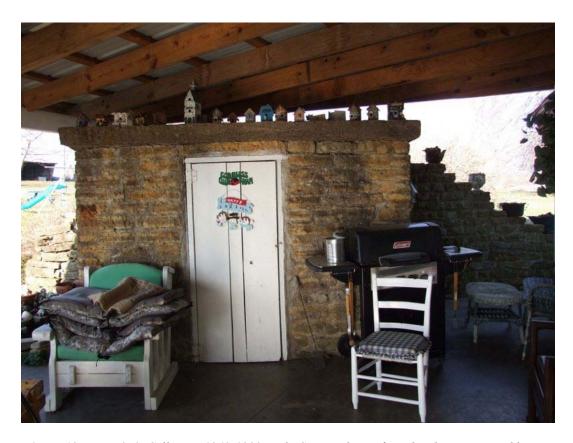
Figure 195: MN 273, Cellar, ca 1860-1900, Holy Cross. The roof overhead is a recent addition.

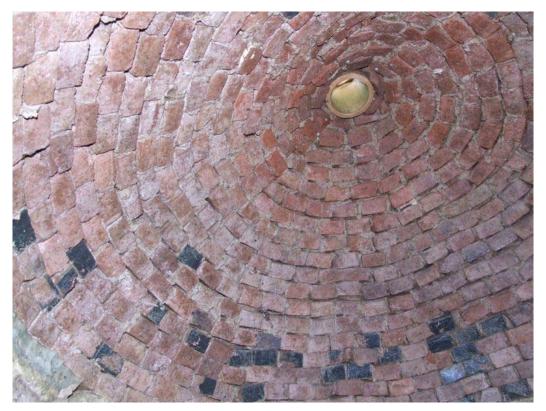
Figure 196: MN 273, Cellar, ca 1860-1900, Holy Cross. Interior view of brick dome ceiling.

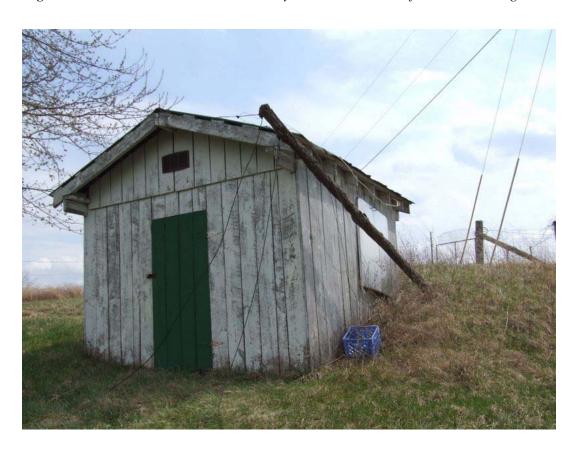
Figure 197: MN 480, Cellar with Frame Entry Shed, early-mid twentieth century, Pottsville vicinity.

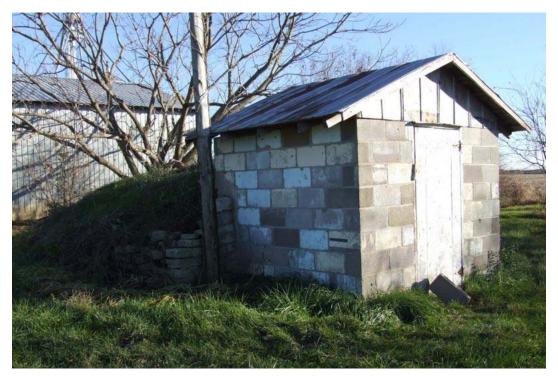
Figure 198: MN 205, Mid-twentieth century Concrete Block Entry Shed over older Brick-lined Cellar, Holy Cross vicinity.

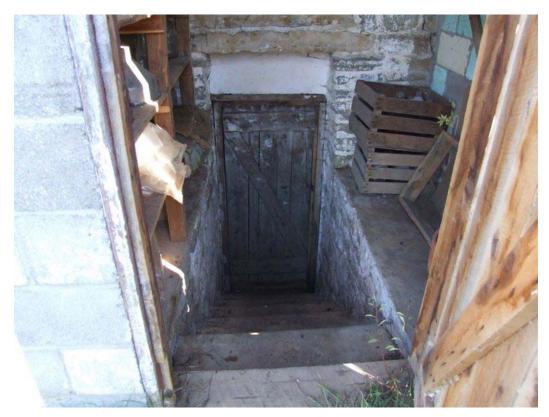
Figure 199: MN 205, view inside Entry Shed.

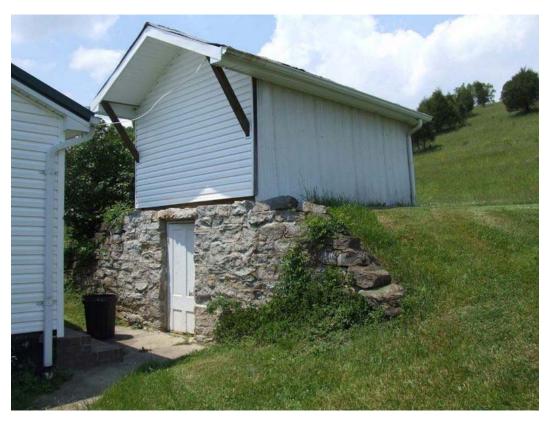
Figure 200: WS 812, Stone-lined Cellar with frame Dry Storage Structure above, late nineteenthearly twentieth century, Tathum Springs vicinity. The upper level is accessed by a door in back.

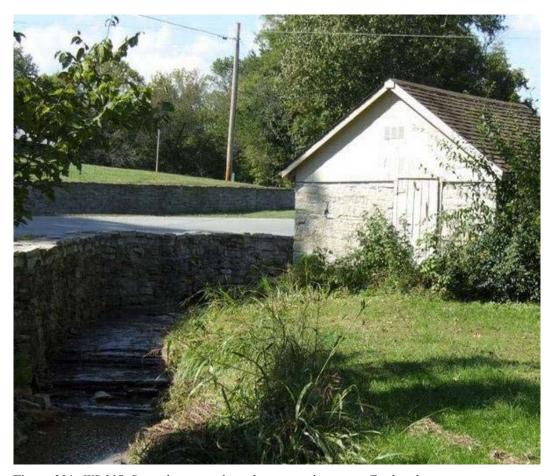
Figure 201: WS 317, Springhouse, early-mid-nineteenth century, Fredericktown vicinity.

Springhouses are common on rural farms of the nineteenth century. The springhouse at WS 317 is a good early example (Figure 201). Like the cellar, the springhouse was an important outbuilding for the storage of food, but also protects the source of water. Where the cellar held items such as root vegetables and apples, a spring house was often used for the storage of dairy items such as milk, cream, cheese, and butter. Spring houses are usually masonry structures or at least their foundations are because of the building's contact with water. The masonry also provides some insulation from summer heat. Just 14 examples were documented in the current survey. This may be a reflection of the greater numbers of later nineteenth - early twentieth century sites in the current survey. Inside the springhouse, water was typically channeled into a trough where it could pool to a convenient depth. Covering the spring just where it emerges from the ground captures the water at its coolest temperature and maximum cleanliness. Some springhouses have a second floor above the spring room, a small dry storage area, the use of which may have varied from structure to structure as at WS 579 (Figure 203).

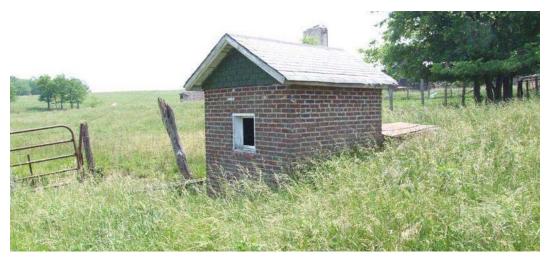
Figure 202: WS 877, Springhouse, late nineteenth-early twentieth century, Springfield vicinity.

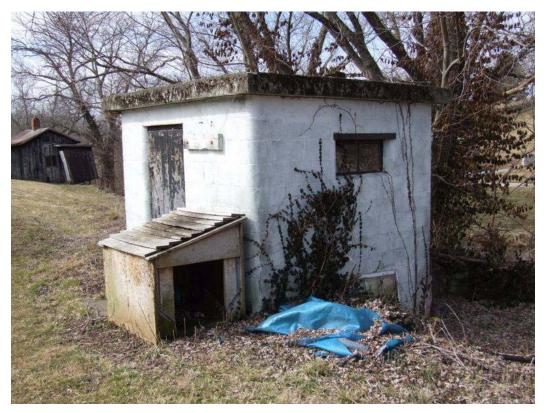
Figure 203: WS 579, Springhouse, early-mid twentieth century, Texas vicinity.

The development of well pumps, cisterns, and plumbing in the late nineteenth century, and particularly refrigeration in the twentieth century eventually made springhouses obsolete. Even so, those surveyed include examples from the twentieth century (WS 579, Figure 203, and MN 65, Figure 204).

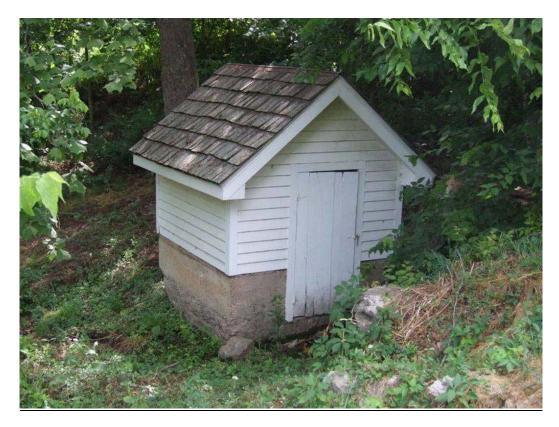
Figure 204: MN 65, Springhouse, early twentieth century, Lebanon vicinity.

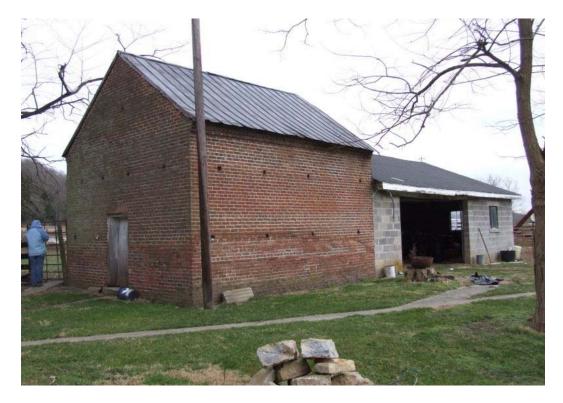
Figure 206: WS 187, Brick Smokehouse, Manton vicinity, early nineteenth century. A substantial and early brick example, with a corbelled cornice and a much later concrete block addition in back.

143 meat and smoke houses were documented in the RHDI area. The typical example is a square or rectangular plan building about 8-12' on each side, with a single door centered on the narrow front of the building and a front gable roof (see WS 187 Figure 206, below, which is an unusually early and substantial brick meathouse, but typical in form). Many of them have a projecting gable that cantilevers a short distance over the entry, providing some shelter in front (WS 630, Figure 205, WS 848, Figure 207). This building type is usually located in back of the house, close to the kitchen and the cellar in the domestic yard (see site plan for WS 476, Figure 3). The most typical examples in the survey region are frame, although masonry and log examples are also present. The larger smoke houses are typically masonry, and in some cases served commercial operations, as in the 1950s concrete block example at WS 333 (Figure 208), where Leo Mudd cured the hams he sold at his nearby store. Masonry smoke houses often have vent holes worked into the walls to allow smoke to escape from the structure (see WS 187 Figure 206, and WS 333, Figure 208).

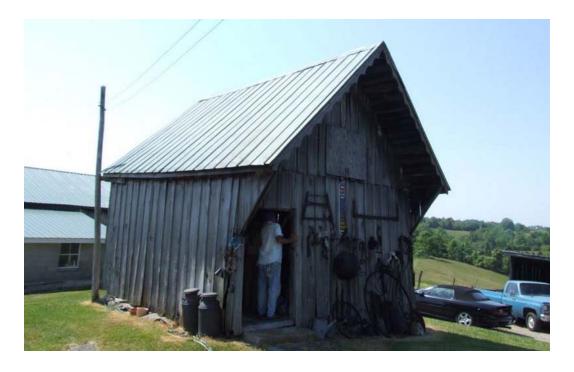
Figure 207: WS 849, Meathouse, late nineteenth century, Willisburg/Brush Grove vicinity. The steep, Gothic style gable and board and batten siding are notable features.

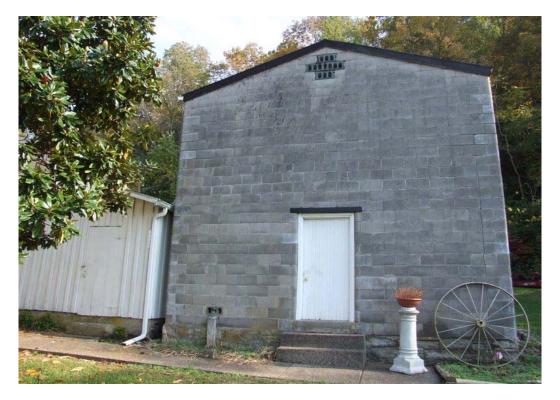
Figure 208: WS 333, Leo Mudd's Smokehouse. Built in the 1950s by Leo Mudd in concrete block, on the cut stone foundation of an earlier smokehouse. Leo was known for the high quality of the hams he smoked here and sold from his store. The ventilators at the peaks and at regular intervals above the foundation were created by turning the blocks sideways.

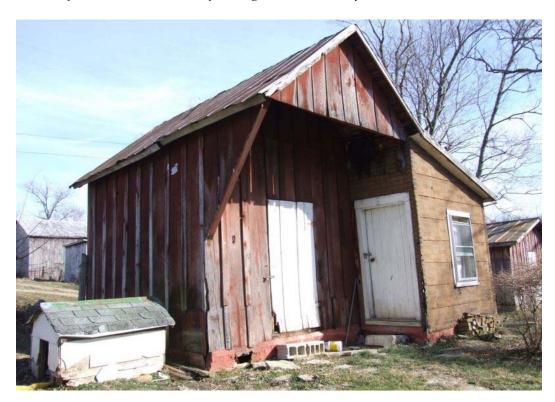
Figure 209: WS 476, Meathouse with side shed, early twentieth century, Mackville vicinity. The shed to the side has two windows and a brick chimney for a stove.

Several meathouses in the survey area are combined with cellars or storage sheds in dual-purpose structures. For example, the meathouse at WS 476 (Figure 209), a projecting front gable type, has a side shed that runs the full length of the roof, with a separate door to the shed also under the roof's cover. The shed area has windows and a stove flue. Though its use is unclear, the flue is clearly significant and suggests cooking or boiling. Smoking may have taken place in one room and salting or brining in the other. Many others, such as the examples at WS 630 (Figure 205) and MN 567 (Figure 210) have unheated attached sheds that appear to be used for tool storage (at least at the present time, if not historically).

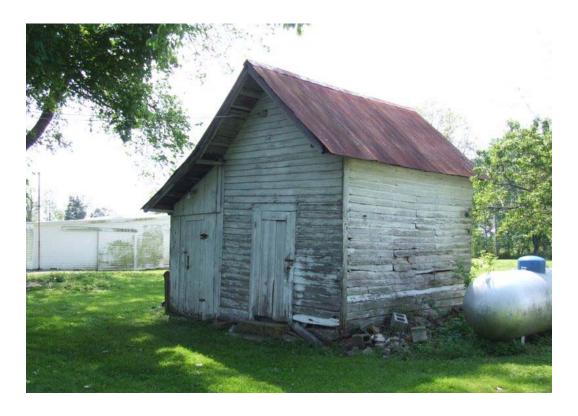
Figure 210: MN 567, Meat- or Smokehouse, New Market, late nineteenth-early twentieth century. Meat houses frequently have side shed appendages used for various functions such as tool storage.

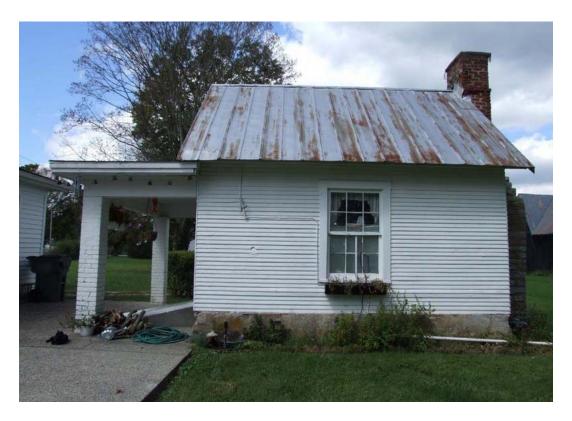
Figure 211: WS 33, Kitchen, mid nineteenth century, Maud. The porch is an early twentieth century addition. The building later served as the Maud Post Office.

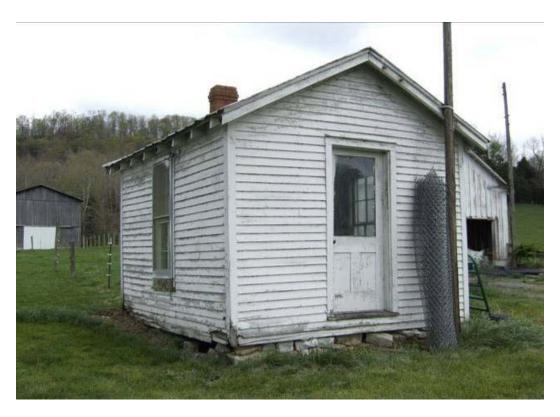
Figure 212: MN 656, Kitchen, early twentieth century, Bradfordsville vicinity. The buildings behind the kitchen include the garage at the right and a multi-purpose barn on the left in the field behind the house. See also Figure 213.

The kitchens documented in rural Marion and Washington counties mostly post-date the period of slavery. Many of them are doubtlessly associated with live-in servants in the Post-Bellum period. Others, particularly those of the twentieth century, are associated with more modest sites, where they were likely used for tasks such as canning vegetables and food processing. Examples from all periods are typically located behind and near to the main house (see the site plan for MN 656, Figure 213), and are close to other domestic food-related structures such as meat houses, cellars, and wells or cisterns. Since they were built for housework, kitchens have strong historic associations with women, children, and family life. Detached kitchens of more recent vintage may have been built for the convenience of separating the kitchen from the house. In many cases, kitchens also served as the laundry facility and frequently served as the dwelling of a slave or live-in cook. Several examples were documented in the survey area that date as late as the 1930s (MN 656, Figure 212).

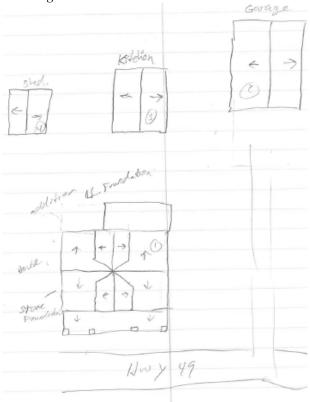
Figure 213: MN 656, Site plan. Building # 4, marked "shed," appears to be a meat house (field notes: Danielle Jamieson & Anna Ruhl, 4/7/2007). See also Figure 212.

The garage is typically located conveniently close to the house, at the edge of the domestic yard area, but not too close to critical outbuildings. At WS 476 (see site plan, Figure 3), a two-car, shed roof garage (Figure 224) is located just off the main road, across the driveway from the house, nearest to the shop and the privy (for another example see the site plan for MN 656 in Figure 213).

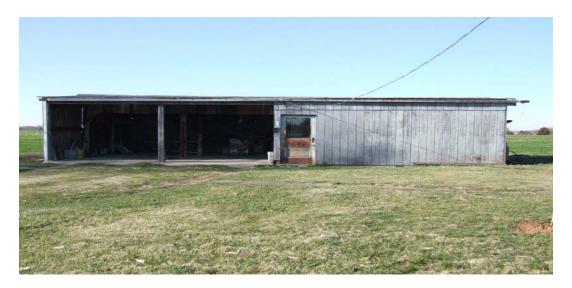
Figure 215: MN 426, Machines Shed/Workshop, mid twentieth century, Loretto vicinity.

two separate rooms inside, suggesting that the building serves multiple purposes. Shops are often found in multi-purpose buildings, most often combined with automobile or farm machinery storage, as at MN 426 (Figure 215).

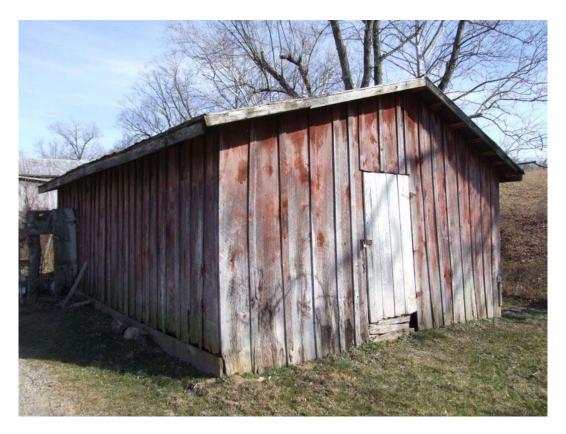
Figure 216: WS 476, Workshop or Tool Shed, mid-twentieth century, Mackville vicinity.

Workshops are a common feature of the rural landscape. Depending on the function of the workshop, which may vary from woodworking to general tasks to machine repair, they could be located near the house, but also within the agricultural complex. Over 40 shops were documented in the area: the numbers are difficult to pin down as some buildings could not be readily identified and others share purposes with garages, tack storage, or machine sheds. Over 700 resources were identified simply as "sheds" in the survey. Although their original function is not always certain, some of these buildings were likely used for the storage of tools or agricultural equipment, and in some cases they may also have served as shops (Figure 216).

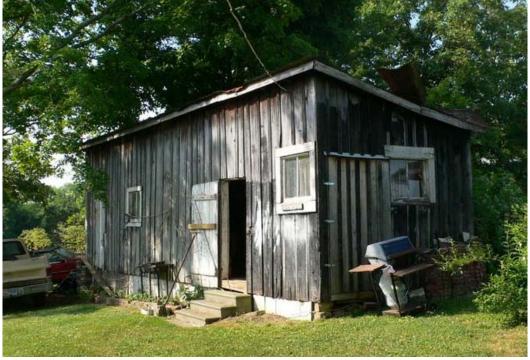
Figure 218: MN 933, Workshop, early – mid twentieth century, Bradfordsville.

Probably the oldest identified shop is the small building at MN 322 (Figure 217), which served as a small woodshop and has a workbench inside. Whether or not this was its original function is unclear – it has a chimney for a stove flue and the Greek Revival detailing of the cornice identifies it as a building of some importance. A far more typical example of a shop in the survey area is found at MN 933 (Figure 218), a shed roof structure which has two doors and presumably

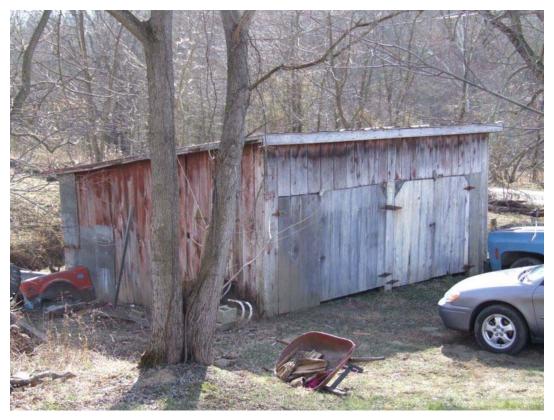
Figure 224: WS 476, Garage, early-mid twentieth century, Mackville vicinity.

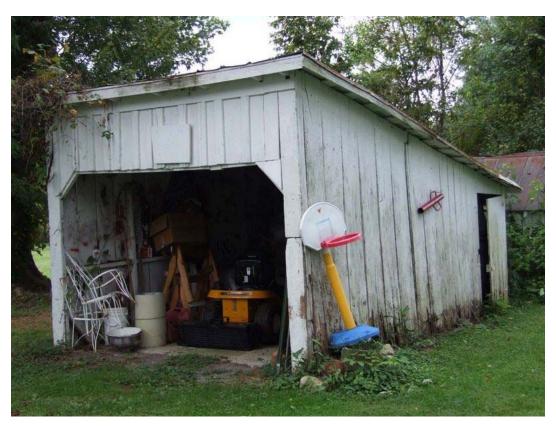
Figure 225: WS 270, Early-mid twentieth century frame Shed Garage, Maud.

The most common garage type in the survey area is a single story building, sometimes nothing more elaborate than a shed roofed shelter with or without doors (see WS 270, Figure 225), ranging to more elaborate examples with accommodations for multiple vehicles. In some cases, a second story was found being used as an apartment, studio, storage, or workspace (MN 936, Figure 226). Garages are sometimes shared between two or more dwellings, as at WS 349-50 (Figure 101).

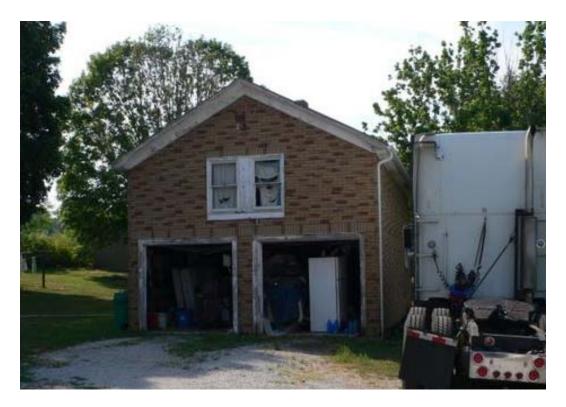
Figure 226: MN 936, 1920s-1930s frame two-car Garage with Apartment or Studio on second floor, Bradfordsville.

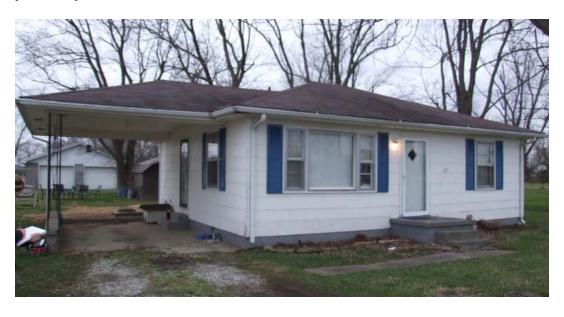
Figure 227: MN 432, Ranch style House with attached Carport, 1940s-50s, Loretto.

Garages were not commonly integrated into the design of houses until the Post WWII period. Many early ranch style houses accommodated cars through the use of an open carport. This feature helps emphasize the horizontality of the Ranch style (MN 432, Figure 227), and is frequently enclosed at a later date to create more living space. Although earlier examples are known, the incorporation of the garage into the main structure of the house itself is not common until the late 1950s-early 1960s (WS 961, Figure 228). Garages are sometimes incorporated into rural roadside commercial structures (see WS 556, Figure 229).

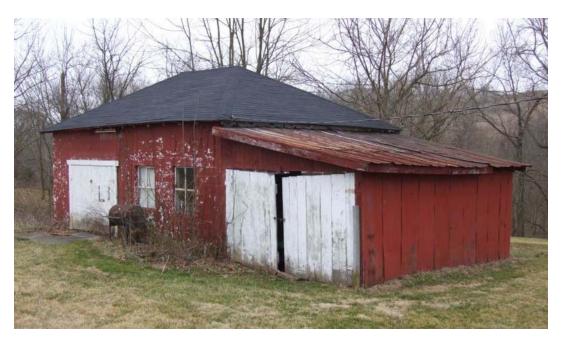
Figure 229: WS 556 Garage/Gas Station, mid twentieth century, Pottsville vicinity.

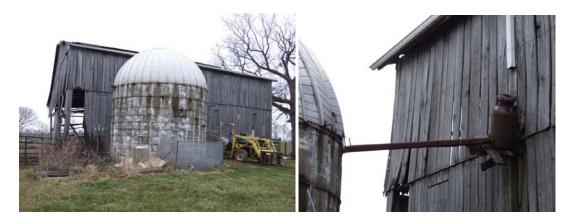
Figure 230: MN 474, Multi-purpose Barn, early-mid twentieth century, with adjacent concrete Cistern, and detail right, Pottsville vicinity. Note the milk can used to connect the guttering.

Good sources of water are crucial in both agricultural and domestic settings, and most of the farm sites surveyed have both wells and cisterns, often several of each. Almost 500 wells and cisterns were documented, taken together, one of the most common resources in the survey. Wells are dug to access ground water. Cisterns are storage tanks filled with the runoff from a roof. There is frequently a domestic cistern gathering water from the roof of the house and another cistern attached to a barn for watering the animals (MN 474, Figure 230), sometimes mistaken to be a short silo. Wells are typically located near the house, although auxiliary wells may be located in the agricultural area. Ultimately, the location of the well depends on where water can be found most readily. Both wells and cisterns are frequently capped by pumps (WS 476, Figure 231; WS 877, Figure 232). Cisterns are often distinguished by their large cement covers as opposed to the smaller caps on dug wells.

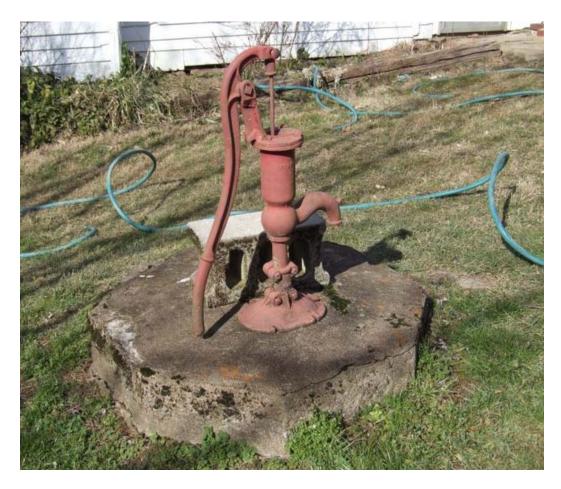
Figure 231: WS 476, Well and Pump, twentieth century, Mackville vicinity.

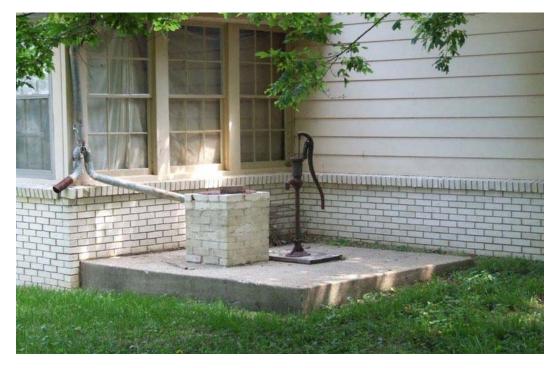
Figure 232: WS 877, Cistern with Pump, Ward House, 1930s, Springfield vicinity.
